ENVIRONMENTAL MONITORING REPORT ON DEPARTMENT OF ENERGY FACILITIES AT GRAND JUNCTION, COLORADO, AND MONTICELLO, UTAH, FOR CALENDAR YEAR 1984

March 1985

**Nic Korte and Sandra Wagner
Bendix Field Engineering Corporation
Grand Junction Operations
Grand Junction, Colorado 81502**

**Prepared for the U.S. Department of Energy
Assistant Secretary for Nuclear Energy
Grand Junction, Colorado, Projects Office
Under Contract No. DE-AC07-76GJ01664**

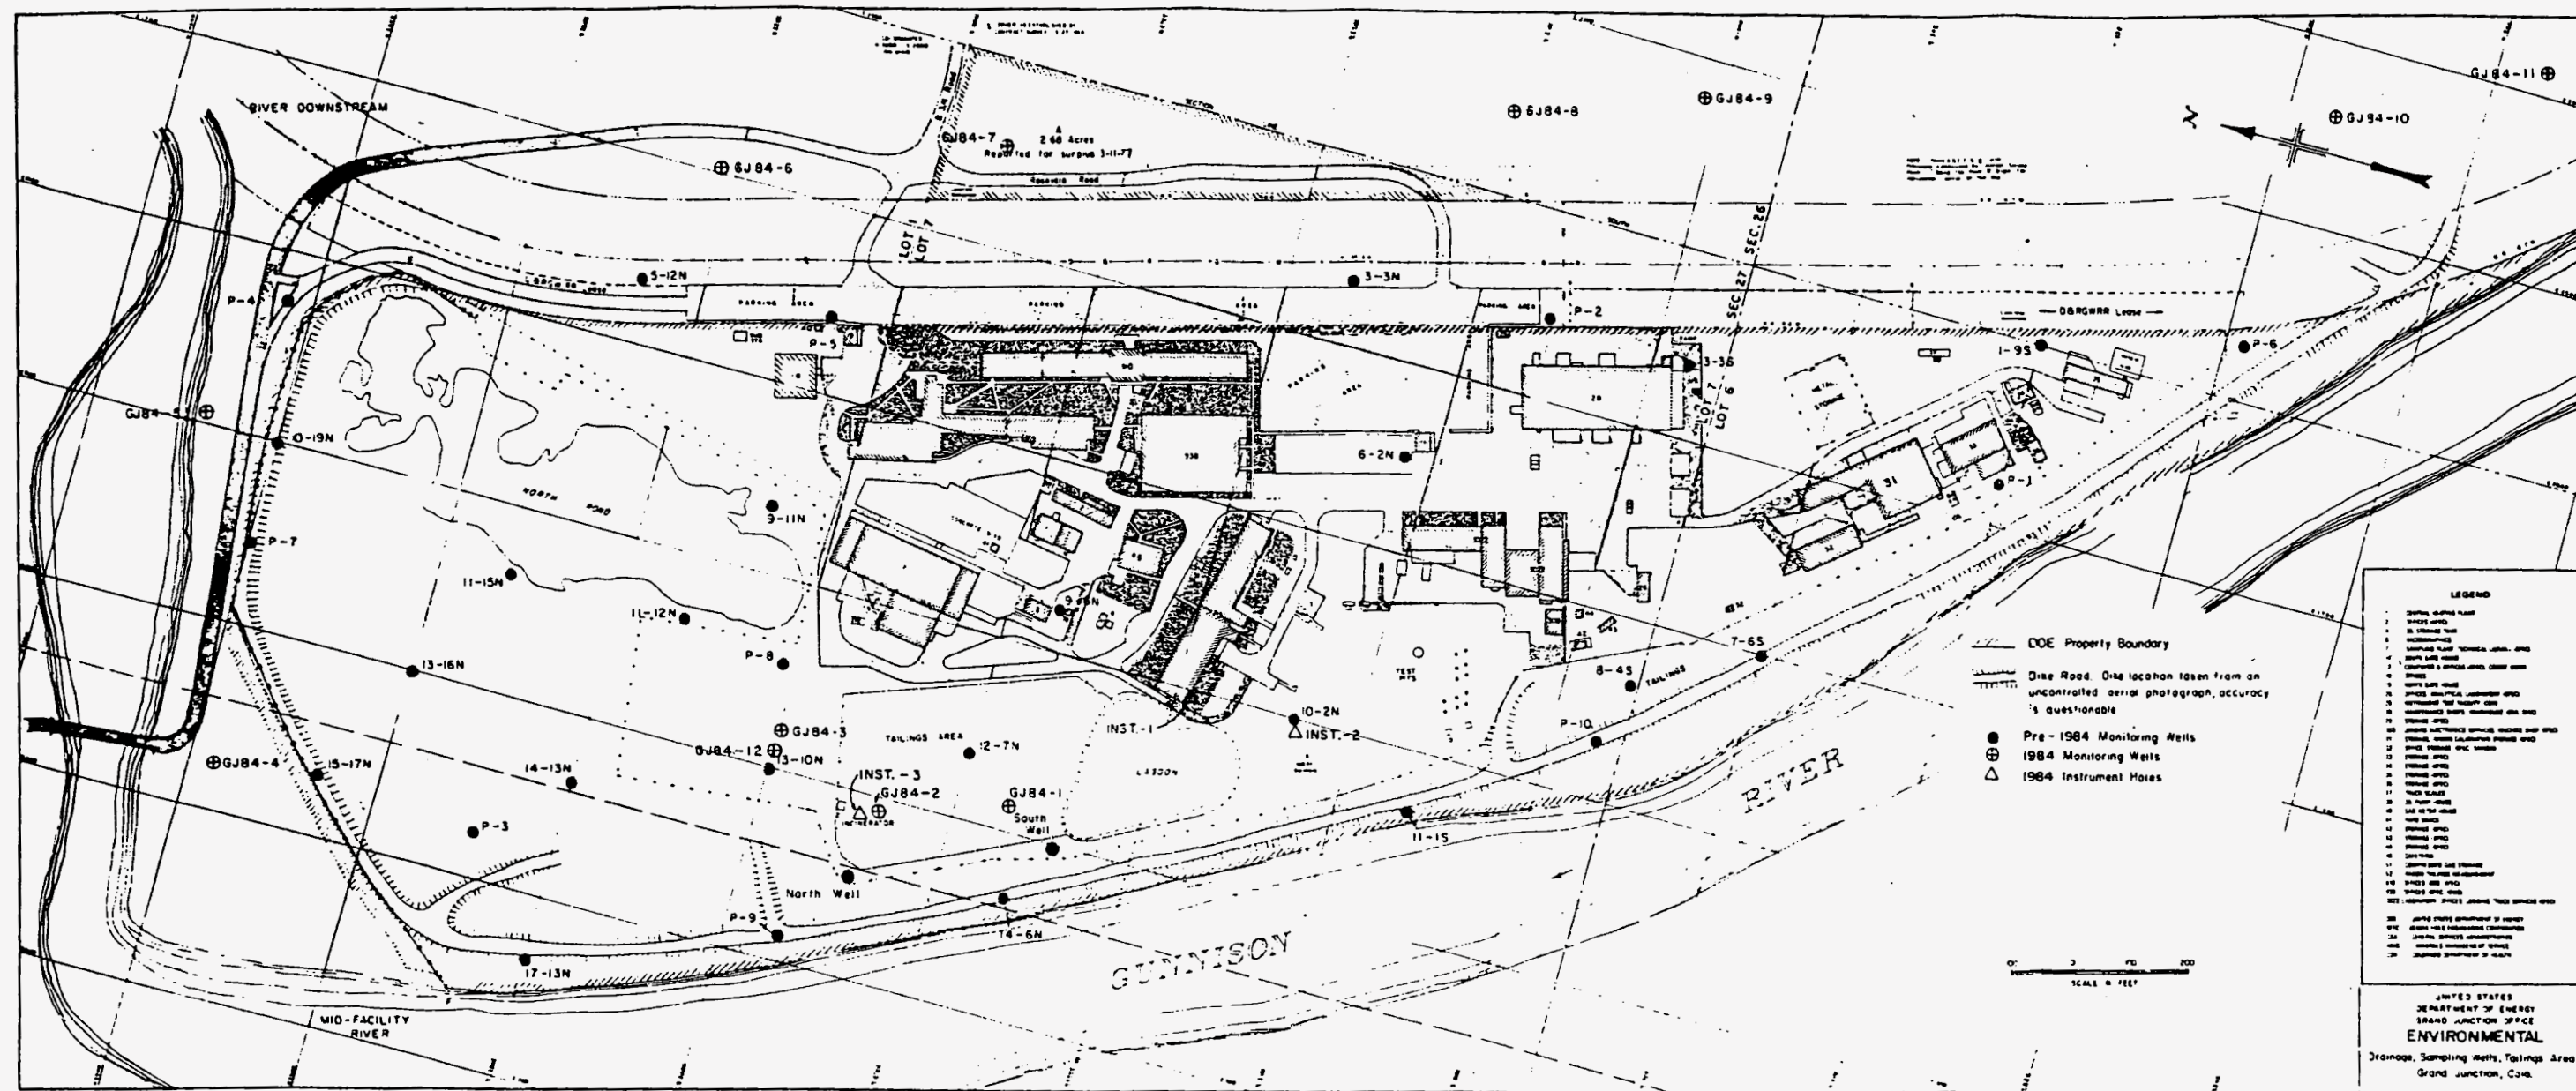
Figure III-1. Locations of Drainage, Sampling Wells, and Tailings Area at the Grand Junction Projects Office Facility

Figure III-1 shows the surface water sites sampled in 1984. The North Pond is contaminated principally by uranium; recharge is primarily from the shallow

The South Pond ('Lagoon' on Figure III-1), also recharged primarily by the shallow gravel aquifer, was formerly used as a sewage lagoon. Currently, its principal source of effluent is storm runoff from the parking lots. Variable contamination by uranium has been observed: The sample collected in December 1983 contained nearly 0.1 mg/l; the February 1984 sample contained only 0.06 mg/l; while the May 1984 sample, collected following a very rainy Spring, contained 0.55 mg/l. This last value decreased to 0.3 mg/l by the time of the August sampling. Clearly there is a need for additional hydrologic testing to determine the cause of these fluctuations.

Previous environmental monitoring reports refer to a sampling location known as the drainage ditch. This area is located outside the facility fence directly west of the buried tailings area and below the river dike. Formerly, the South Pond overflowed into the ditch more or less continuously; however, it has been observed on numerous inspections that the pond has not contained sufficient water to overflow since the facility was connected to the city sewer system in 1981. Nevertheless, water remains in the ditch area except during very dry seasons. Results of chemical analysis of the ditchwater indicate some substantial fluctuations since the South Pond overflow ceased. Radium-226 was not detected in 1982, was as high as 59 pCi/l in 1983, and averaged 46 pCi/l in 1984. The concentrations of uranium and molybdenum also remain high, the former exceeding 1 mg/l and the latter exceeding 0.4 mg/l.

Based on results of the 1981 data, Wells P-2, P-6, 1-9S(D), 3-3N(D), and 5-12N(D) (Figure III-1) were expected to represent background. (The designation 'D' denotes a two-well multilevel system at the particular location.) Results of subsequent samplings, however, indicate that this assumption is erroneous. Uranium levels in P-2 and P-6 reported in the 1981 report were less than 0.01 mg/l. During 1982, 1983, and 1984, samples from all five wells contained levels of uranium above the expected background concentration. Uranium contents ranged from approximately 0.02 mg/l in P-2 to more than 0.8 mg/l in the shallow well at location 1-9S. Except for Well 1-9S, the concentration of uranium ranged from 0.02 to 0.06 mg/l. Other anomalies also exist. For example, selenium was detected in Wells 5-12N(D) and 1-9S(D); contamination by zinc, vanadium, and manganese is evident in one or more wells. Thus, it is now believed that none of these five wells represents background. For that reason, additional wells were drilled in 1984 (Sewell and Price, 1984); they are denoted by the prefix GJ84-. Available data indicate that Wells GJ84-9, 10, and 11 represent background (Table III-1).

Uranium contamination is evident in all wells except those new wells that represent background (GJ84-9, 10, and 11). Twenty-six wells contained more than 0.5 mg/l uranium in at least one of the sampling periods. The highest concentrations were found in Wells 8-4S and P-10, which are located west of Building 3022. The uranium levels in most of the other wells were greater than 0.1 mg/l. The average concentration in the wells along the north dike has remained fairly consistent over the past 3 years. Average uranium concentrations of 0.81 mg/l in 1982, 0.88 mg/l in 1983, and 0.86 mg/l in 1984 were determined from data for Wells P-4, 10-19N, P-7, and 15-17N; data from new wells GJ84-4 and 5 were included in the 1984 averaging. The uranium concentrations along the west boundary (Wells 11-1S, P-10, 7-6S, and 8-4S) were at least 2 mg/l in each of the four sampling periods in 1984, with a high value of 4.8 mg/l. Several of these wells are located on the river dike.

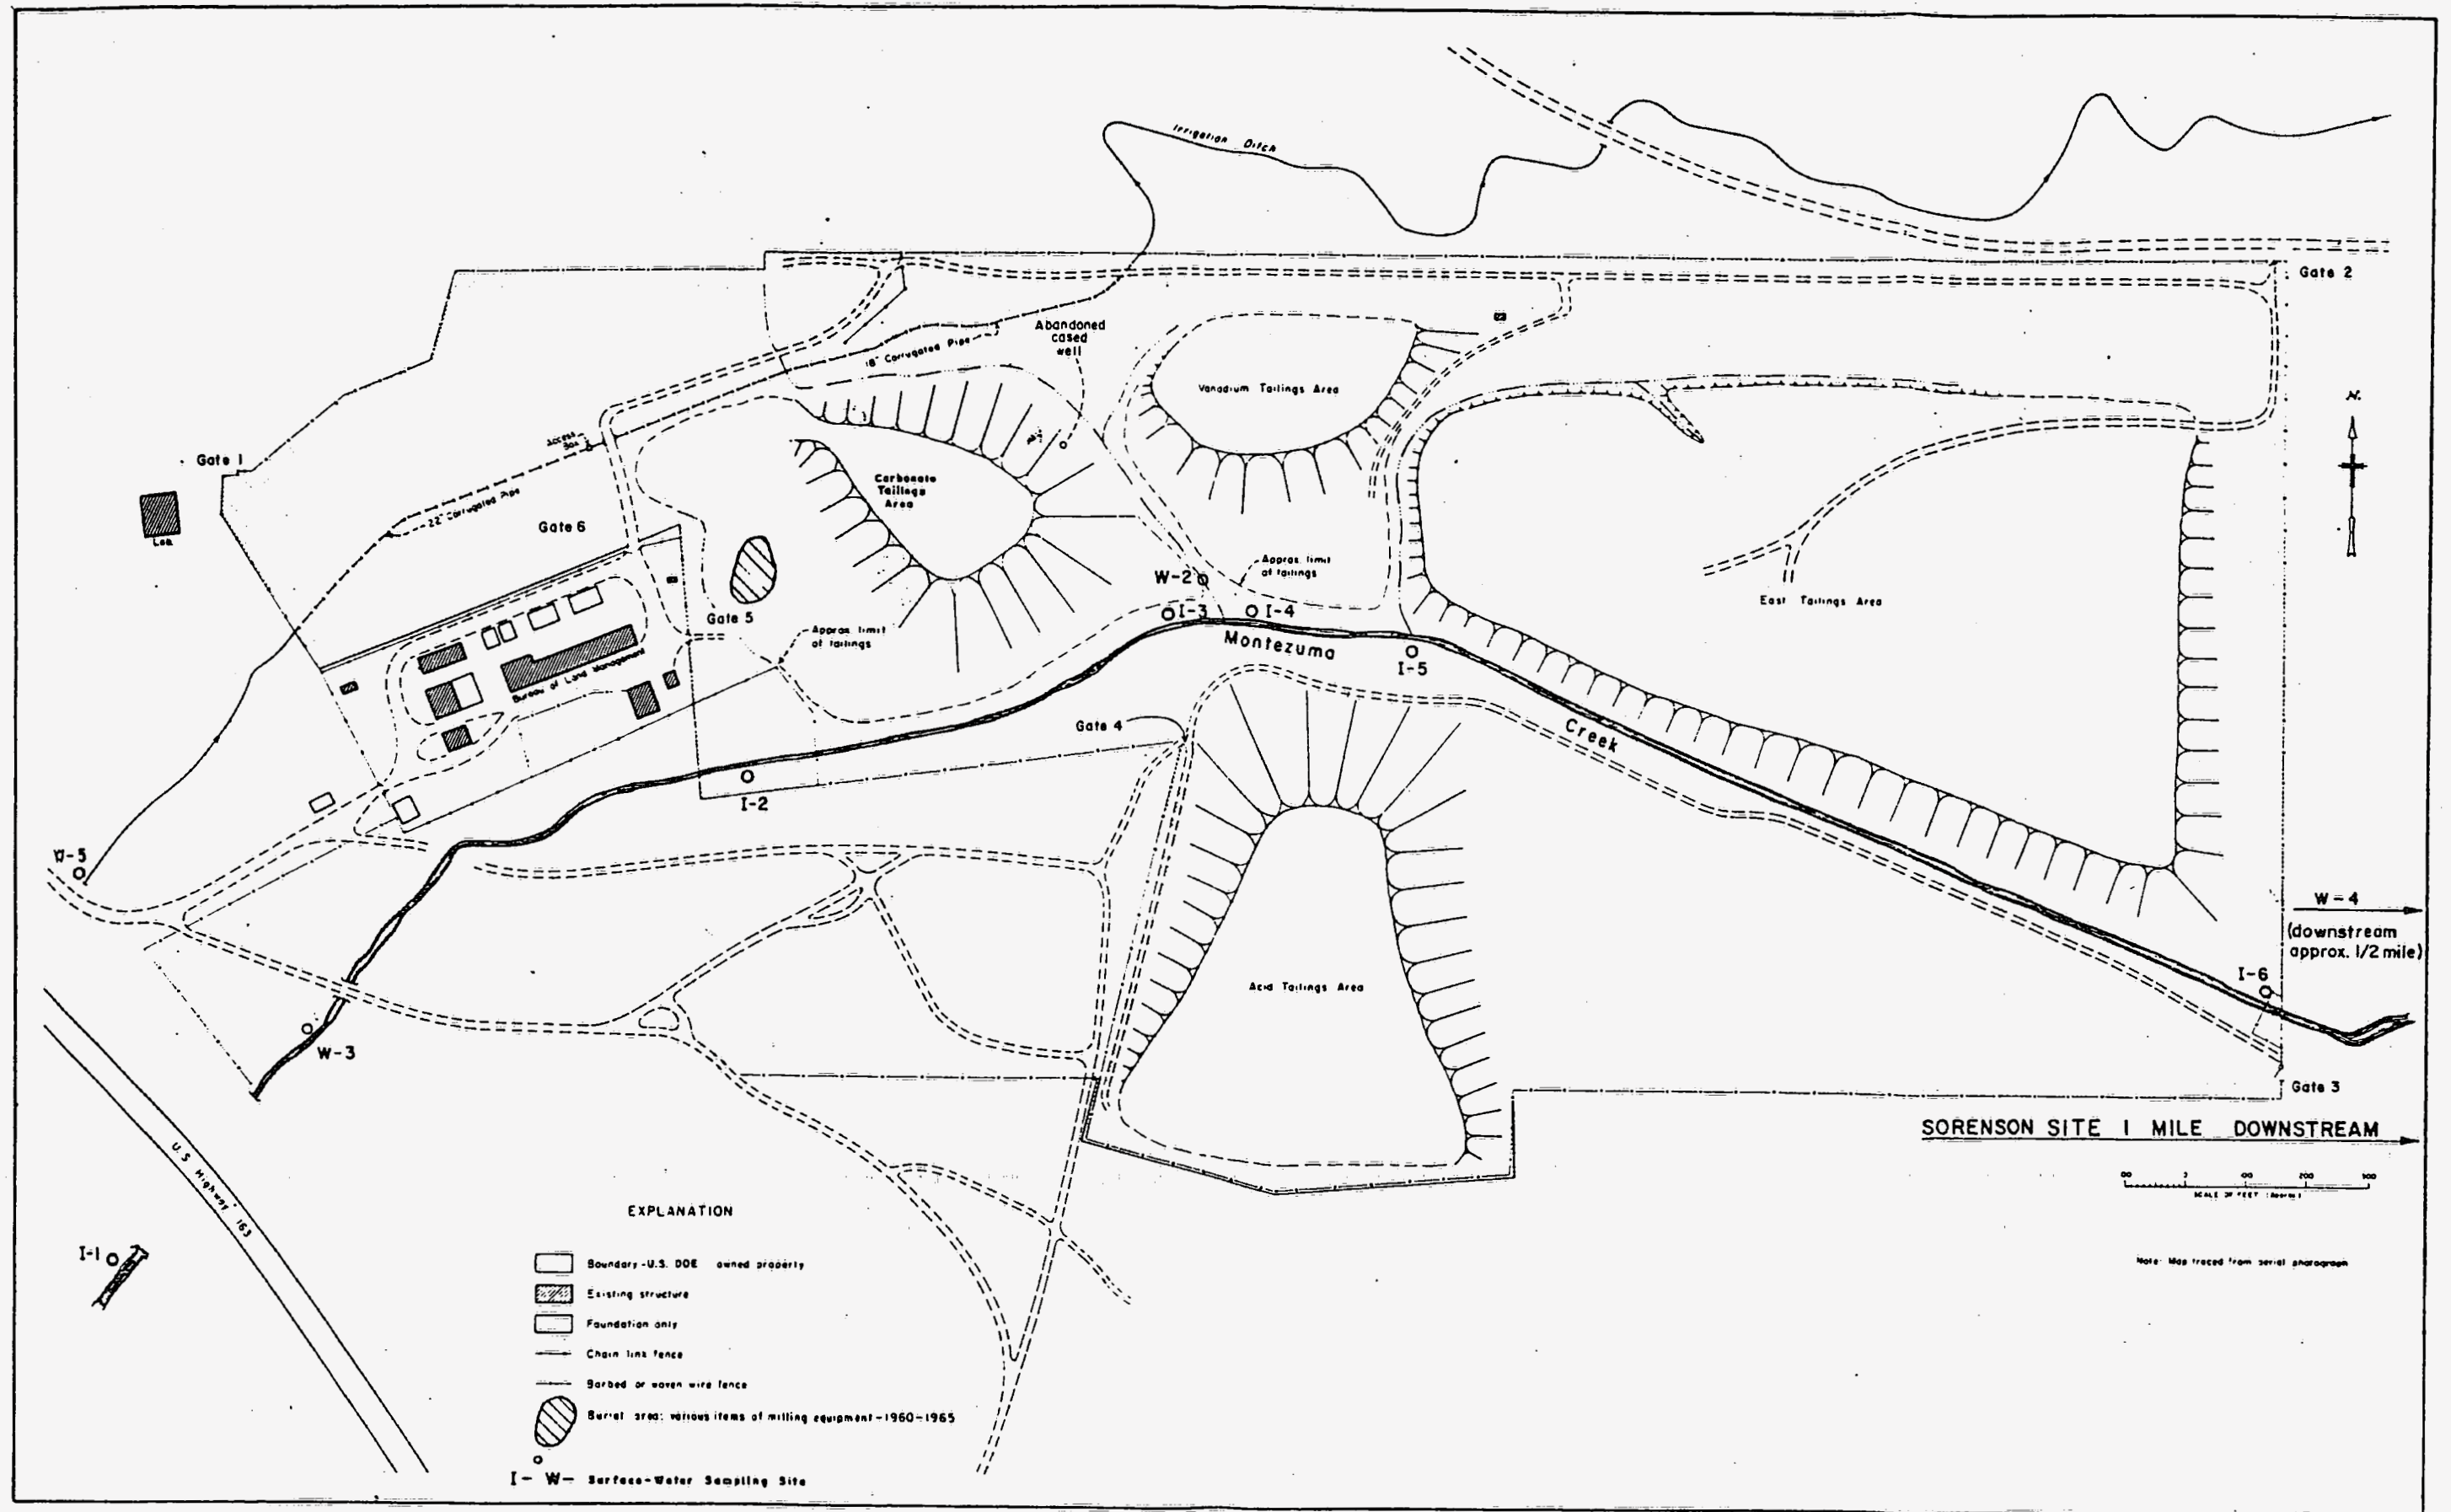
Figure IV-1. Sampling Locations for Surface Water at the Monticello Millsite

Background surface-water quality has been monitored for some years at the site labeled W-3 in Figure IV-1. This sampling point is located east of the culvert under Highway 163. Upstream samples (site I-1) have also been collected to verify that the W-3 site accurately represents the background water quality of Montezuma Creek (Korte and Thul, 1982, 1983).

Permanent surface water on the Government property consists of perennial flow in Montezuma Creek and in the drainage between the carbonate and vanadium piles (drainage designated W-2 on the map in Figure IV-1). There is intermittent water in seeps south of the carbonate and vanadium piles and east of the acid pile. The vanadium and acid pile seeps contain water in the Spring following snowmelt. The seep adjacent to the vanadium pile generally covers an area up to 5 square meters to a depth of 15 to 30 centimeters. The acid pile seep is contained by a small dam and is, when full, approximately four times larger in area than the vanadium pile seep.

Seeps from the shallow aquifer are visible along the creek below the drop structure. Creek flow increases for approximately 2 kilometers and is perennial along this stretch. The W-4 sampling site is located approximately 100 meters downstream from the east boundary of the property. Except under conditions of very high flow, as during a storm event or Spring runoff, contamination levels frequently exceed State of Utah standards (see a succeeding subsection, Water-Quality Standards).

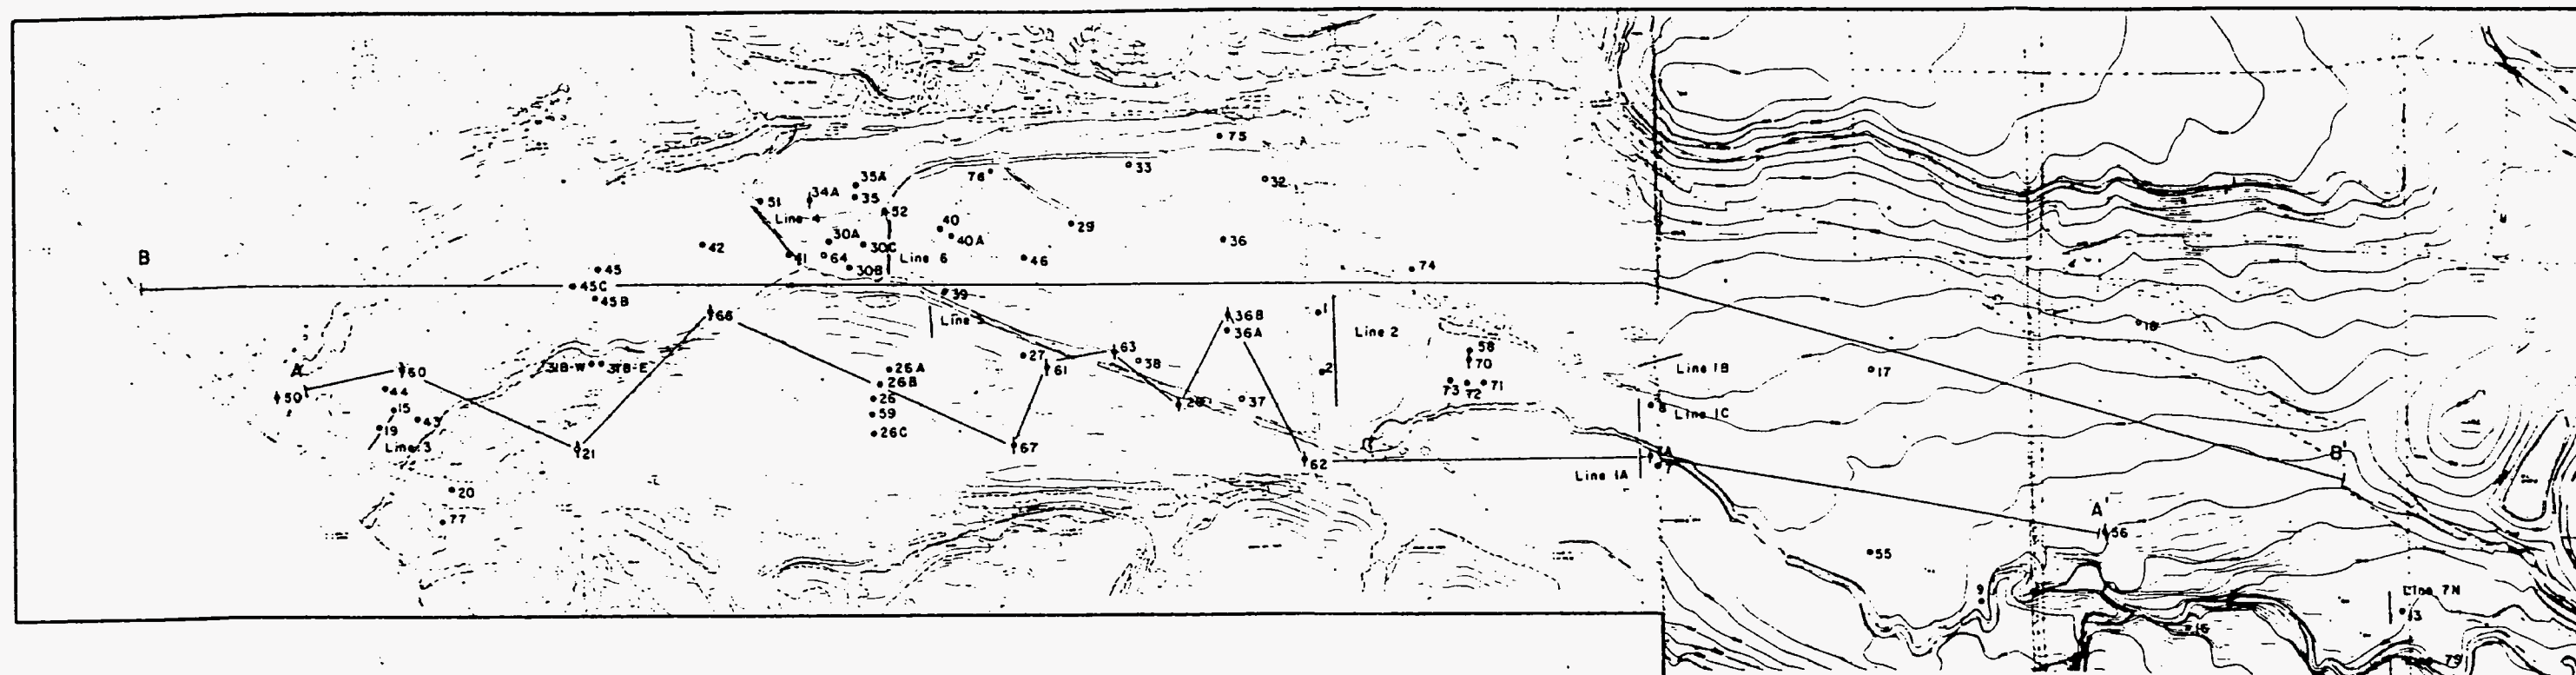
Figure IV-2. Sampling Locations for Groundwater at the Monticello Millsite

Shallow-aquifer background groundwater-quality data have been acquired from Wells 19, 44, 43, and 20 (see Figure IV-2). Elements not detected or found in very low concentrations include As, Ba, Cl, Fe, Mo, Pb, Se, V, and Ra-226. Trace elements found in significant concentrations include Mn (1.1 to 2 mg/l), Zn (0.1 to 5.0 mg/l), and U (as much as 0.05 mg/l in two samples). The pH was found to range from 6.8 to 8.3; specific conductance was measured at 550 to 917 μ mhos/cm, and alkalinity at 250 to 350 mg/l.
